FACILITIES ASSESSMENT

CABRILLO UNIFIED SCHOOL DISTRICT
ADDENDUM, NOVEMBER 13, 2020

HALF MOON BAY HIGH SCHOOL

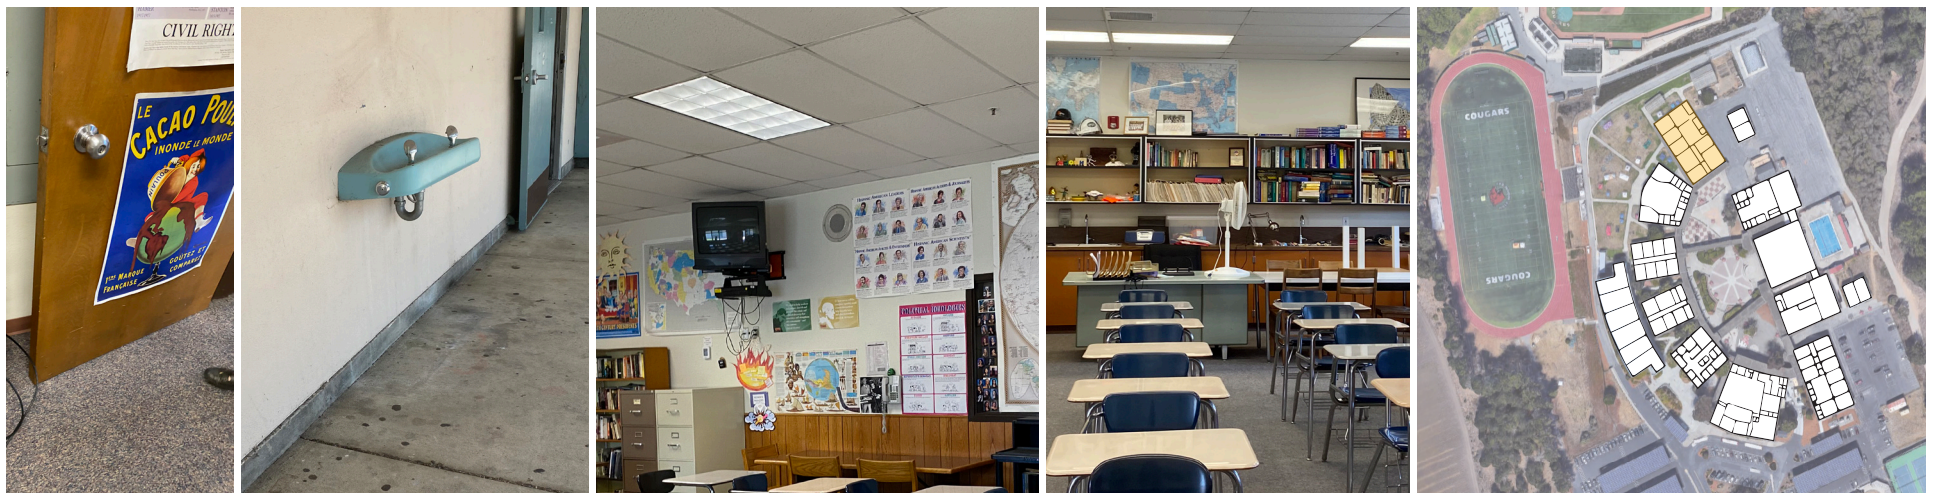
HALF MOON BAY HIGH SCHOOL BUILDING A

- Doors into teacher prep rooms lack accessible hardware
- Drinking fountain is not accessible
- A/V equipment includes unused wall-mounted televisions
- Mechanical units & accessories are outdated
- Carpet has reached the end of its useful life
- Ceiling has sprinklers & ceiling grid is in fair condition
- Interior finishes, aside from the carpet, are in fair condition
- Upper cabinets lack doors, & rooms lack an accessible sink
- Storage is insufficient for current needs

- Replace non-compliant door hardware with code compliant hardware
- Replace drinking fountains with accessible drinking fountains
- Remove unused A/V equipment
- Replace carpet throughout
- Replace and reinsulate the auxiliary heating unit, heating coils, valves, hot water piping and exhaust fans.
- Replace casework and include accessible sink

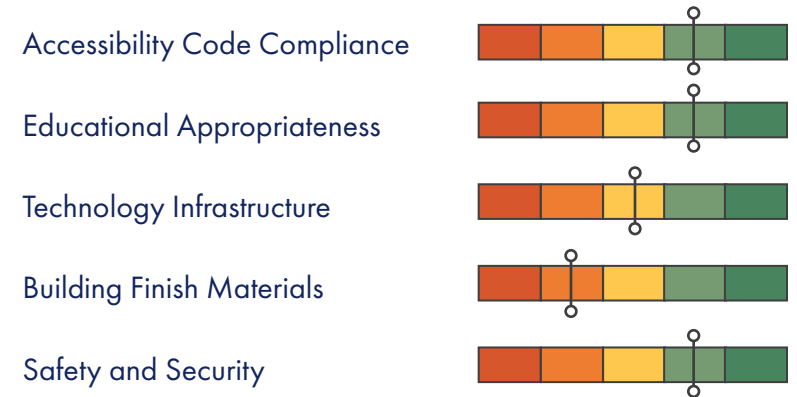
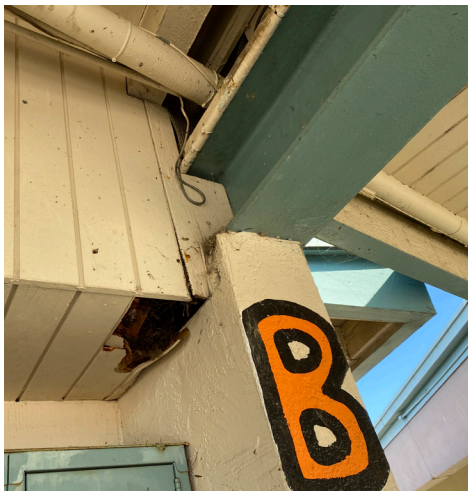
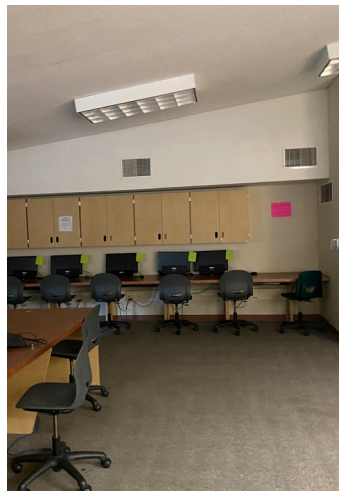
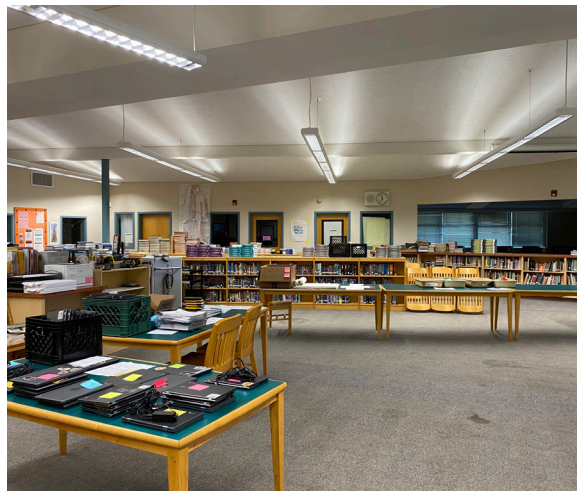
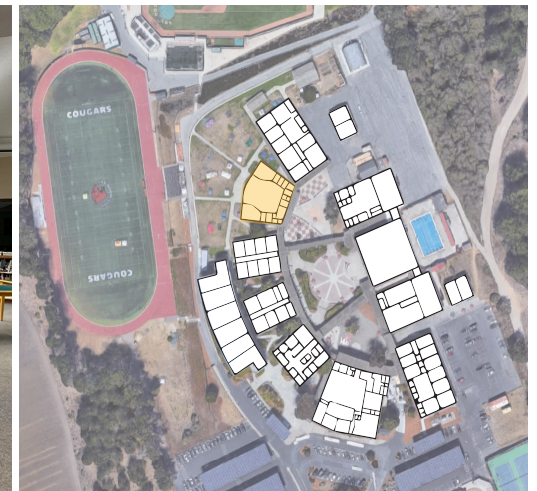
HALF MOON BAY HIGH SCHOOL BUILDING B - LIBRARY

- Mechanical units & accessories are outdated
- Restrooms lack exhaust ventilation system
- The operable area of the windows do not meet current Title 24 ventilation requirements
- Lights have been retrofitted recently with LEDs
- Adhesive-applied ceiling tiles are in good condition
- Window coverings have reached the end of their useful life
- Casework is somewhat dated, but in fair condition
- Exterior shows significant dry rot damage at exterior walkway roof
- Carpet has reached the end of its useful life
- Drinking fountain appears to be code compliant

Building B is located towards the north end of the Half Moon Bay High School campus. It directly faces the central quad. It houses the school library and 2 computer labs. Building B needs exterior repairs, mechanical upgrades, & minor finish upgrades

- Replace and reinsulate the air handling unit, heating coils, valves, hot water piping and exhaust fans.
- Install rooftop exhaust fans for both restrooms
- Replace radiant heaters in classrooms with classroom type unit ventilators
- Repair/replace areas of dry rot
- Replace window coverings
- Replace carpet

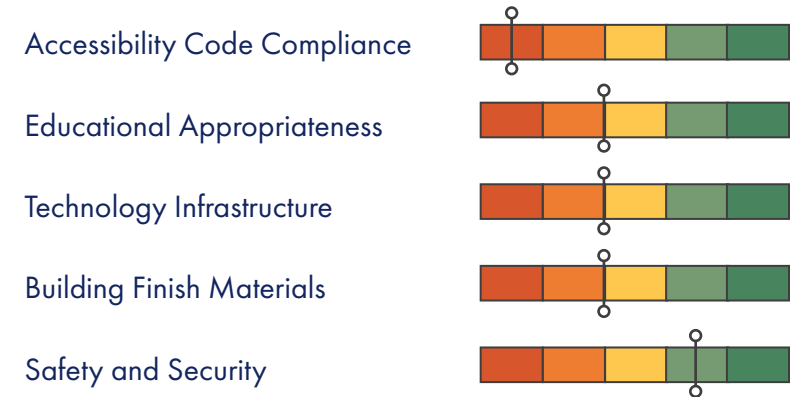
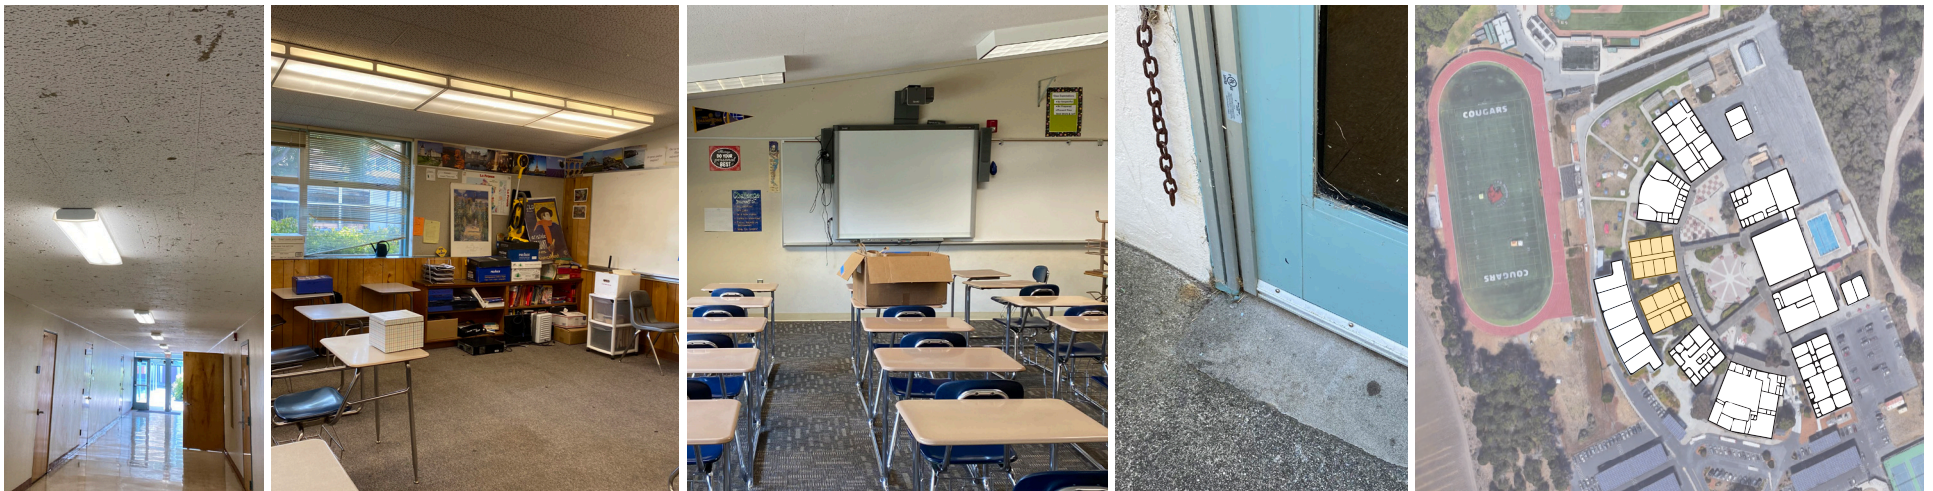
HALF MOON BAY HIGH SCHOOL BUILDINGS C & D

- Exterior door thresholds do not meet current ADA code
- Many classrooms have 1 electrical outlet
- The operable area of the classroom windows does not meet current Title 24 ventilation requirements
- Mechanical units & accessories are outdated
- Select classrooms have been renovated with updated carpet and LED light fixtures
- Adhesive-applied ceiling in hallways shows extensive damage
- Window coverings have reached the end of their useful life

Buildings C & D are located on the west side of the main quad. Building C consists of 8 classrooms and Building D includes 6 classrooms & 2 restrooms. Both buildings need to be updated to meet current ADA standards. They also require mechanical, electrical, & finish upgrades

- Update door thresholds to meet current ADA standards
- Provide a minimum of 4 electrical outlets per classroom
- Replace hallway ceiling tiles
- Replace radiant heaters in classrooms with classroom type unit ventilators
- Replace and reinsulate the air handling unit, heating coils, valves, hot water piping and exhaust fans
- Update classrooms that have not yet been modernized with new LED lighting and new carpet
- Replace window coverings

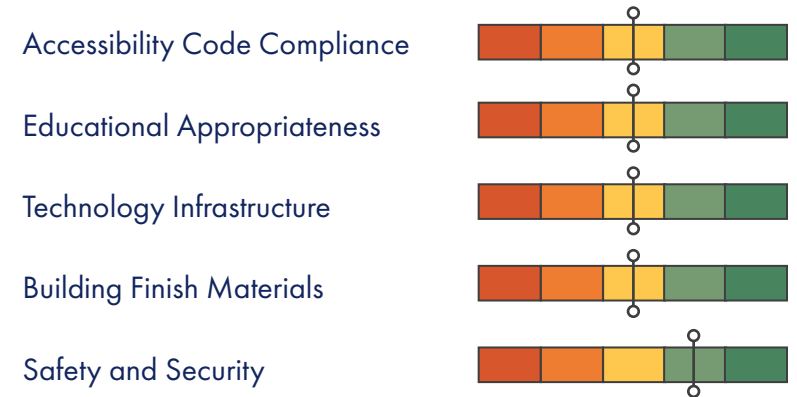
HALF MOON BAY HIGH SCHOOL BUILDING E - ADMINISTRATION

- Mechanical units & accessories are outdated
- Building lacks individual light switches
- The operable area of most windows do not meet current Title 24 ventilation requirements
- Lights have been retrofitted recently with LEDs
- Adhesive-applied ceiling tiles are in fair condition
- Casework is in good condition
- Carpet has reached the end of its useful life
- Interior finishes are in fair condition

Building E, the administration building, is located on the southwest side of the main quad. This building marks the entrance to the school. Building E requires mechanical & finish upgrades

- Replace radiant heaters with classroom type unit ventilators
- Replace and reinsulate the air handling unit, heating coils, valves, hot water piping and exhaust fans
- Replace carpet
- Repair/replace interior finishes

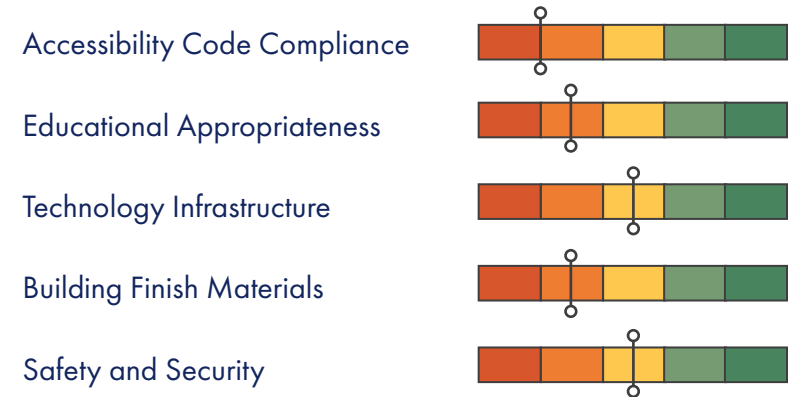
HALF MOON BAY HIGH SCHOOL BUILDING F

- Interior doors lack accessible hardware
- Drinking fountain is not code compliant
- Mechanical units & accessories are outdated
- The operable area of the windows in the auxiliary classrooms does not meet current Title 24 ventilation requirements
- Hot water piping in mechanical rooms show signs of severe leakage in multiple locations
- Walls & roof in band room have water damage
- Casework in the multipurpose room & chorus room has reached the end of its useful life
- Wall, door & stage surfaces are significantly damaged
- Most of the interior finishes have reached the end of their useful life

Building F is located on the south side of the main quad. This building includes the multipurpose room, the kitchen, the band & chorus rooms, & the staff room. Building F requires accessibility, mechanical, & finish upgrades

- Replace non-compliant door hardware with code compliant hardware
- Replace drinking fountain with accessible drinking fountain
- Replace radiant heaters with classroom type unit ventilators
- Replace and reinsulate the air handling unit, heating coils, valves, hot water piping and exhaust fans
- Replace acoustic tiles in band room
- Replace casework
- Repair/replace interior finishes

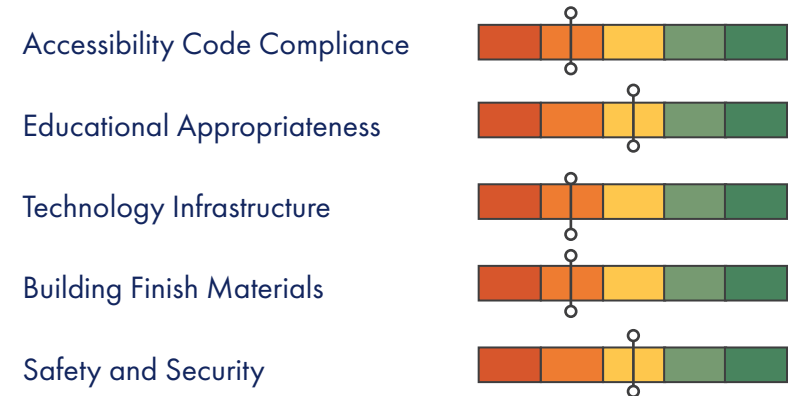
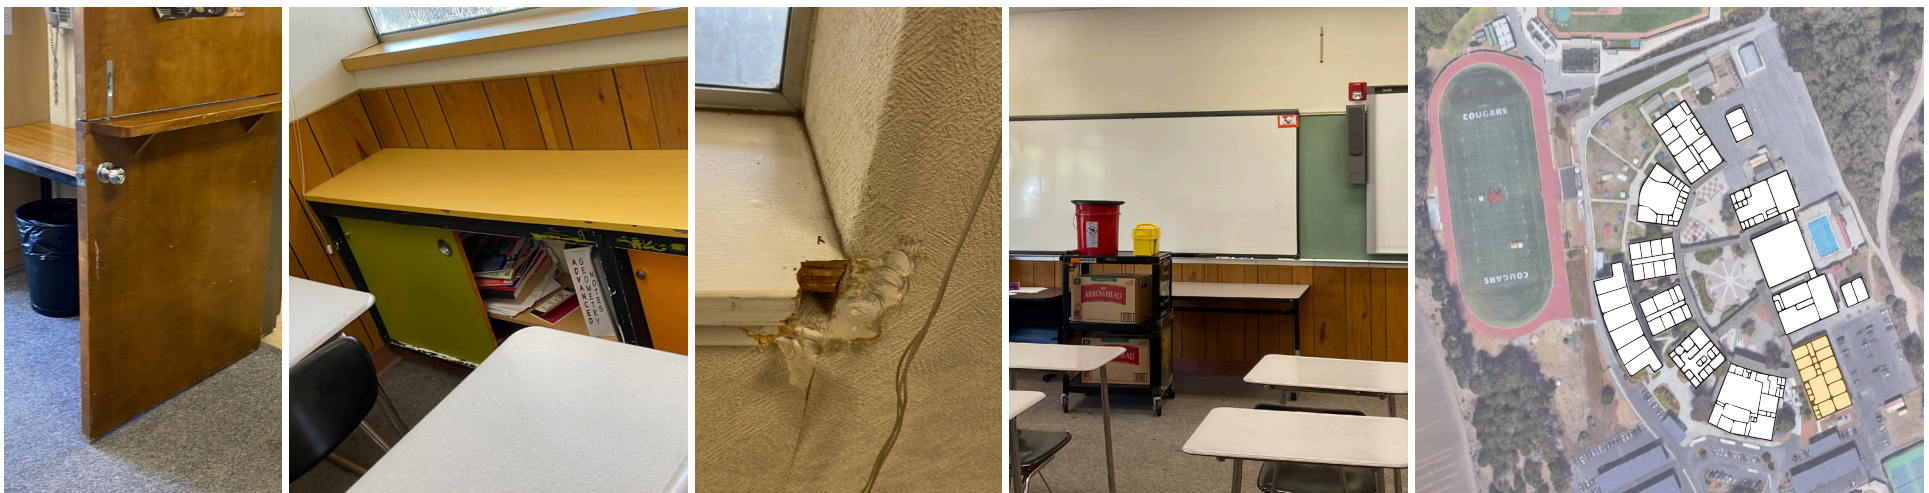
HALF MOON BAY HIGH SCHOOL BUILDING G

- Mechanical units & accessories are outdated
- Interior doors lack accessible hardware
- Carpet has reached the end of its useful life
- Ceiling has sprinklers & ceiling grid is in fair condition
- Window shades have reached the end of their useful life
- Building lacks signage
- Casework has reached the end of its useful life
- Most of the interior finishes have reached the end of their useful life

Building G is located on the south side of the main quad and holds 10 classrooms. Due to its age, Building G needs accessibility, mechanical, & finish upgrades

- Replace and reinsulate the air handling unit, heating coils, valves, hot water piping and exhaust fans.
- Replace non-compliant door hardware with code compliant hardware
- Replace carpet
- Replace window shades
- Add building signage
- Replace casework
- Repair/replace interior finishes

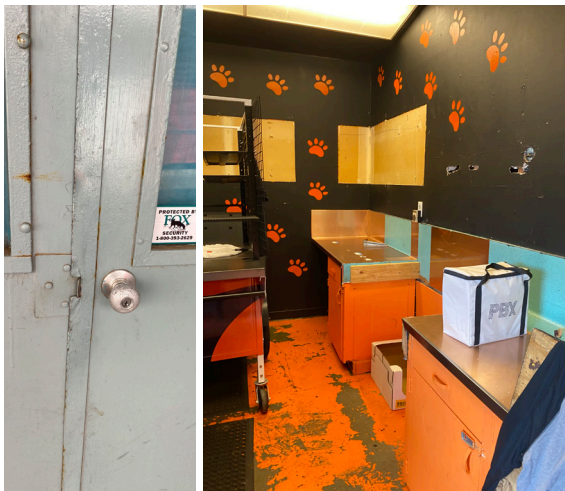
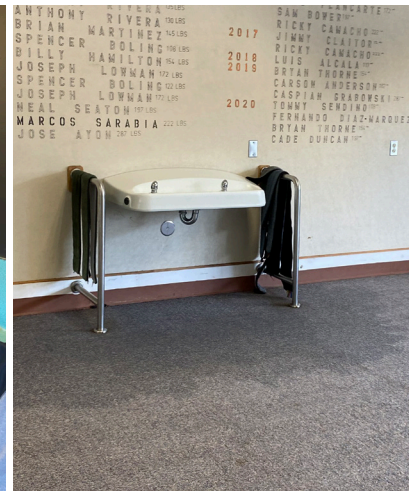
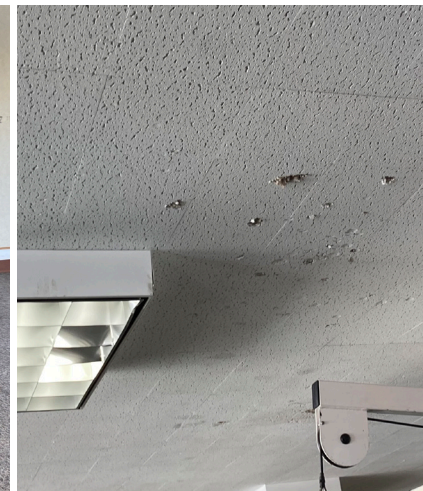
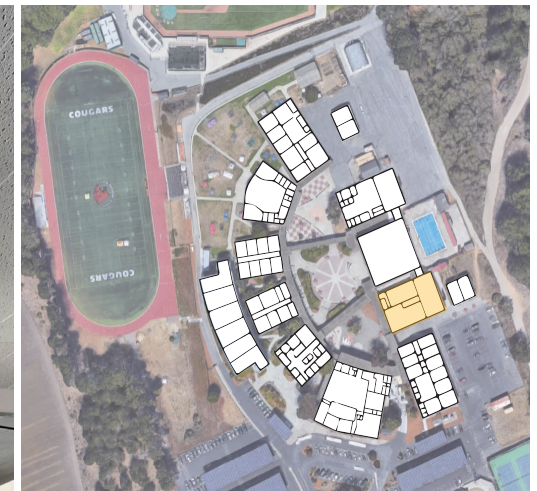
HALF MOON BAY HIGH SCHOOL BUILDING H

- Doors lack accessible hardware
- Drinking fountains are not ADA compliant
- The operable area of the windows in the some rooms do not meet current Title 24 ventilation requirements
- Exhaust fans in the restroom and girls locker room have reached the end of their useful lives
- Ceilings & walls in weight room & mat room show extensive damage
- Mechanical units & accessories are outdated
- Carpet in mat room has reached the end of its useful life
- All finishes in the student store have reached the end of their useful life

- Replace non-compliant door hardware with code compliant hardware
- Replace at least 1 drinking fountain with an accessible drinking fountain
- Replace and reinsulate the air handling unit, heating coils, valves, hot water piping, exhaust fans, & duct insulation
- Replace exhaust fans at the restroom and girls' locker room
- Replace/repair ceilings & walls at weight room & mat room
- Replace carpet in mat room, & all student store finishes
- Replace radiant heaters with classroom type unit ventilators

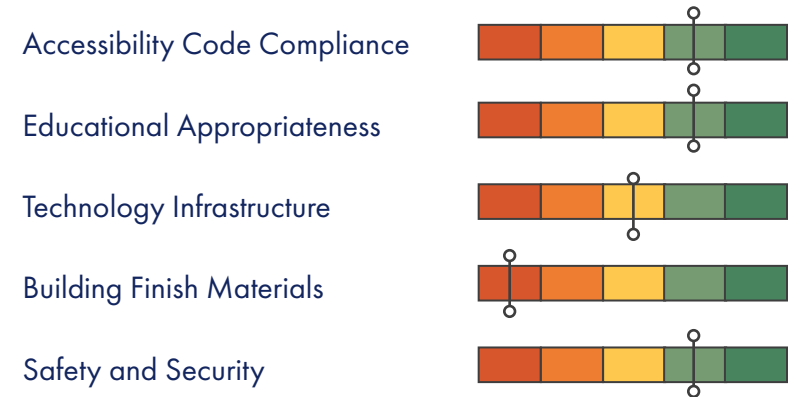
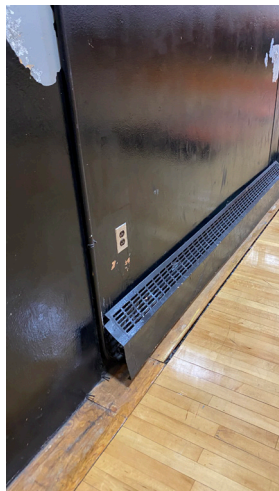
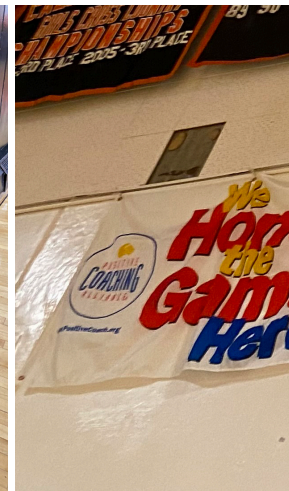
HALF MOON BAY HIGH SCHOOL BUILDING I - GYMNASIUM

- All mechanical equipment has reached the end of its useful life
- Main wood floor is in excellent condition
- Wood floor perimeter plywood is in poor condition
- Some adhesive-applied ceiling & wall tiles are missing
- Breezeway ceiling has extensive damage
- Breezeway doors have broken glass & extensive rust damage

Building I, the gymnasium, is located on the east side of campus directly across the main quad from buildings C & D. Its connected to buildings H & J by breezeways. Building I needs mechanical & finish upgrades

- Replace all mechanical equipment
- Replace wood floor at perimeter
- Repair/replace damaged or missing adhesive-applied ceiling & wall tiles
- Repair breezeway ceiling
- Replace exterior doors at breezeway

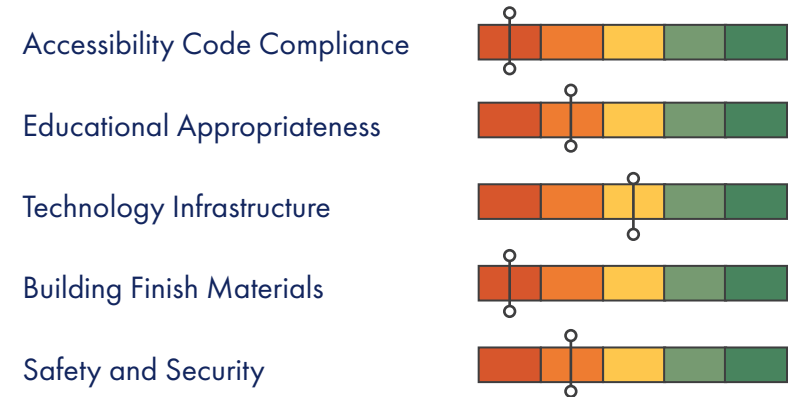
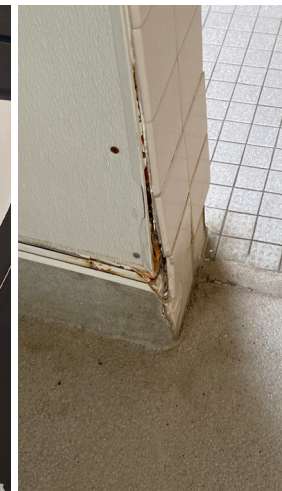
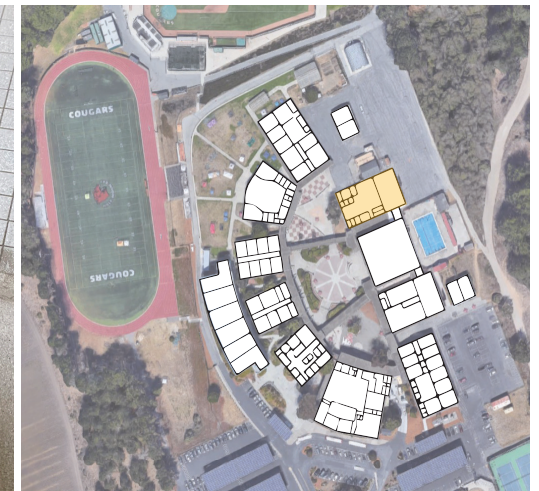
HALF MOON BAY HIGH SCHOOL BUILDING J

- Building lacks accessible hardware, entrances & fixtures
- Shop floor consists of asbestos tile over concrete
- Mechanical units & accessories are outdated
- Ceiling around skylights shows water damage
- Shower walls in boys' locker room are damaged
- Finishes in boys' locker room have been patched multiple times

Building J is located on the north side of campus and a breezeway connects Building J to the Gym. Building J includes the shop and boys' locker room. Building J needs significant accessibility, mechanical, & finish upgrades

- Replace non-compliant door hardware with code compliant hardware
- Replace concrete pads & thresholds to make all doors code compliant
- Remove asbestos floor tile
- Replace and reinsulate the air handling unit, valves, & hot water piping
- Replace exhaust fans in restroom & boys' locker room
- Provide an accessible sink & drinking fountain at the shop & boys' locker room
- Provide an accessible urinal & toilet at boys' locker room
- Replace wall finishes in boys' locker room
- Repair & reseal skylights

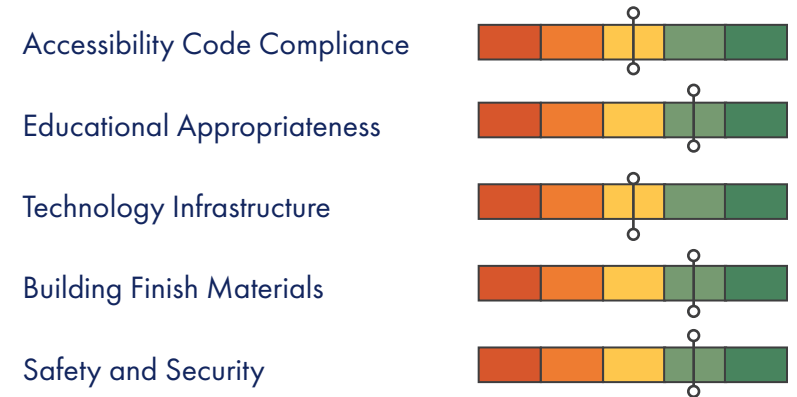
BUILDING K

- Hollow metal windows are rusted
- Areas around hollow metal windows have water damage
- Multiple classrooms lack an accessible sink
- Outside drinking fountain is not code compliant
- AC units, associated thermostat & exhaust fans are outdated
- Exterior exposed metal has significant rust damage
- Interior finishes are in fair condition

Building K is located on the west side of campus and is the only two-story building on campus. Building K holds 12 classrooms including the science & art classrooms. Building K needs accessibility, mechanical, & finish upgrades.

- Replace hollow metal windows and repair water damage
- Provide 1 accessible sink per classroom
- Replace exterior drinking fountain with accessible drinking fountain
- Replace AC units, associated thermostat & exhaust fans
- Repair/replace exterior exposed metal

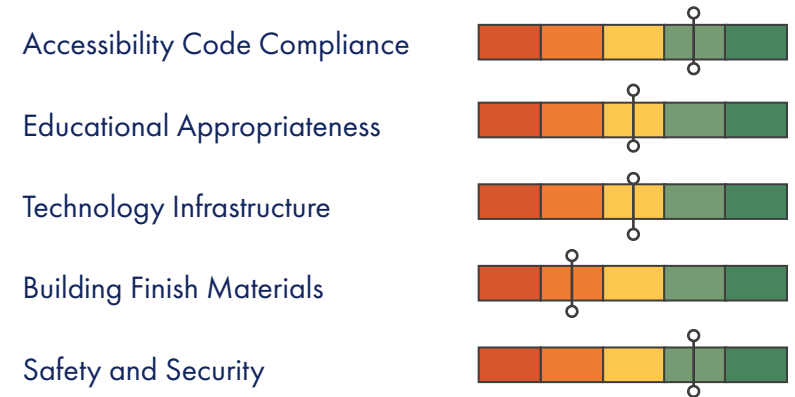
HALF MOON BAY HIGH SCHOOL BUILDING P - PORTABLES

- Carpet has reached the end of its useful life
- Wall base has reached the end of its useful life
- Wall surface is damaged
- Multiple ceiling tiles are missing or damaged
- Lights have not been upgraded to LEDs

Building P consists of 2 portables located at the east side of campus. Each portable houses a single classroom with attached bathroom. Both portables require finish upgrades.

- Replace interior finishes
- Repair wall surfaces where necessary
- Replace damaged or missing ceiling tiles
- Upgrade lights to LEDs
